Navigation Antenna Coaxial Cable Package Installation

Installation Instructions Part Number

23497542

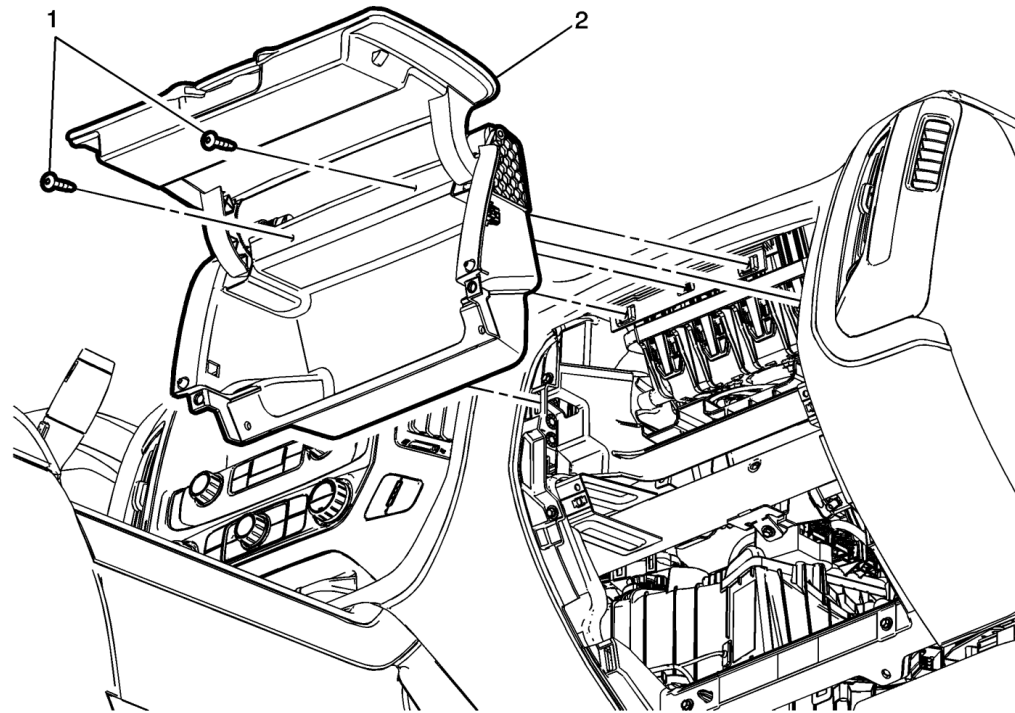
9. Remove the instrument panel upper compartment bolts (1).

Upon reassembly, tighten the instrument panel upper compartment bolts to 2.5 N.m (22 lb in).

10. Using a flat-bladed plastic trim tool, release the retainer clips securing the instrument panel upper compartment (2) to the instrument panel assembly.
